Pentium® Pro Processor Specification Update

Release Date: November 1997

Order Number: 242689-022

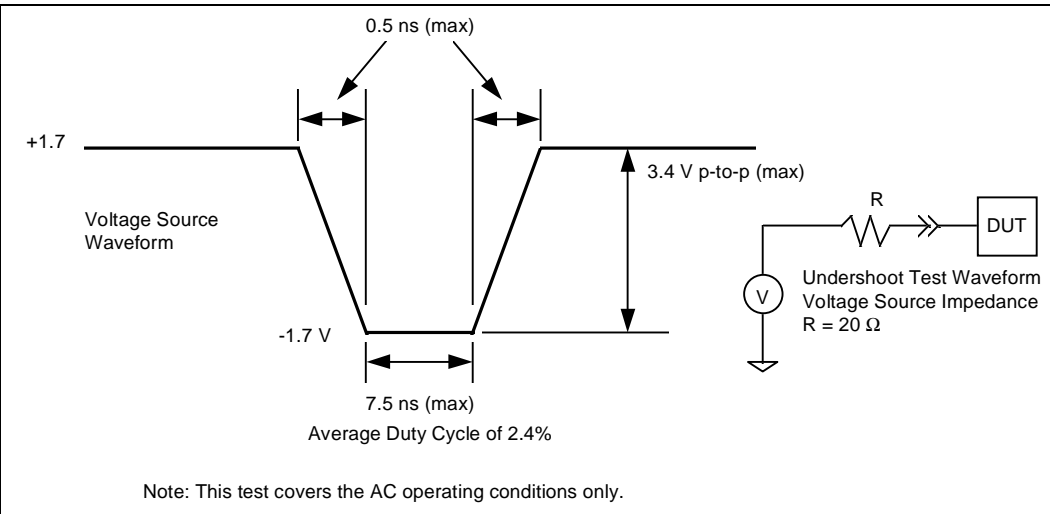
The Pentium Pro processor bus signals AERR#, BERR#, BINIT#, BNR#, HIT#, and HITM# (only) are capable of sinking an 85 mA current pulse at 2.4% average time duty cycle. This is equivalent to -1.7V applied to a 20Ω source in series with the device pin for 8 ns at 66 MHz with a utilization of 5%.

The *Pentium® Pro Family Developer's Manual, Volume 1: Specifications*, Section 11.15., will include the following undershoot specification, to simplify signal integrity issues on signals that can be driven by more than one device simultaneously:

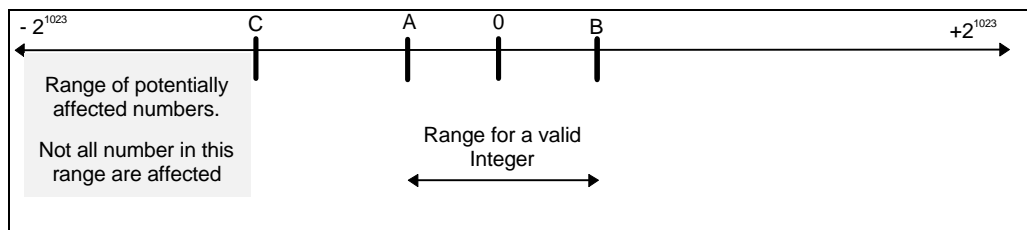
IMPLICATION: Erroneous operation results when the operand is so large that it will not fit into the target data size. The operands affected by this erratum are significantly outside (by a factor of 3X) the range that can be, correctly, converted to an integer value. The figure below and corresponding table identifies the normal range of integer numbers (between A and B) and the starting point of the operands affected by this erratum. Discrete failing operands will be present in the range between point C and the maximum negative number that can be represented by the processor (-2^{1023} in double precision format). Note 2 below gives a qualitative description of the nature of the discrete failing values. Software that does not rely on the Invalid Operation exception flag being set and signaled by either an exception OR by software polling is not impacted by this erratum.

16-bit Operation	A	B	C
	-32,768.0	+32,767.0	< -98304.0
32-bit Operation	A	B	C
	-2,147,483,648.0	+2,147,483,647.0	< -6,442,450,944.0

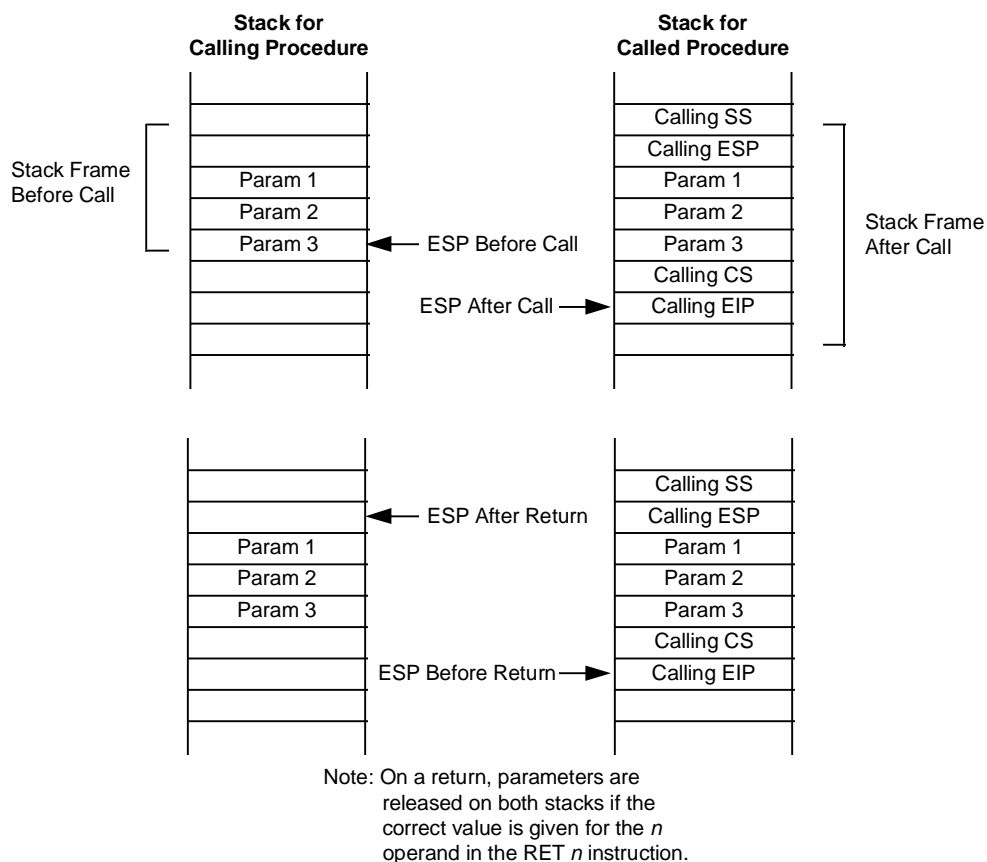
When making a call to a more privileged protection level, the processor does the following (see Figure 4-3):

Figure 4-3. Stack Switch on a Call to a Different Privilege Level

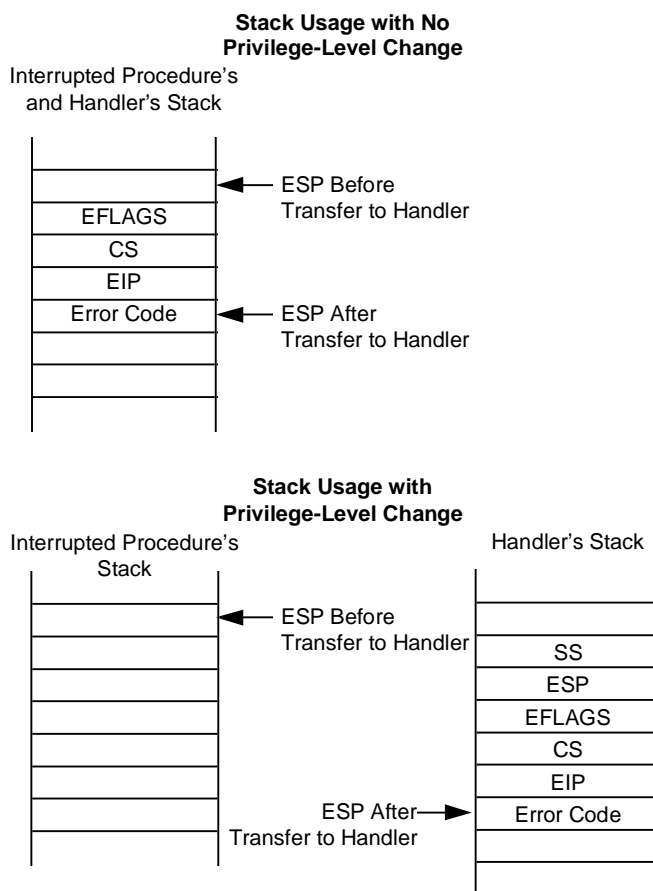
1. Performs a privilege check.
2. Restores the CS and EIP registers to their values prior to the interrupt or exception.
3. Restores the EFLAGS register.
4. Restores the SS and ESP registers to their values prior to the interrupt or exception, resulting in a stack switch back to the stack of the interrupted procedure.
5. Resumes execution of the interrupted procedure.

Figure 4-4. Stack Usage on Transfers to Interrupt and Exception Handling Routines
